INDOOR AIR POLLUTION MIGRATION TRANSPORT MECHANISMS
IN HIGH-RISE BUILDINGS

This engineering case treats an indoor air pollution problem that occurred in a high-rise building. It illustrates the air migration problems that exist within high-rise buildings which can act as transport mechanisms for buoyant air pollutants. It also demonstrates some of the air engineering methods that can be applied to prevent or inhibit such migration problems.

John W. Fothergill, Jr.
Integrated Systems, Inc.
(a Maryland corporation)
P. O. Box 128
Brunswick, MD 21716

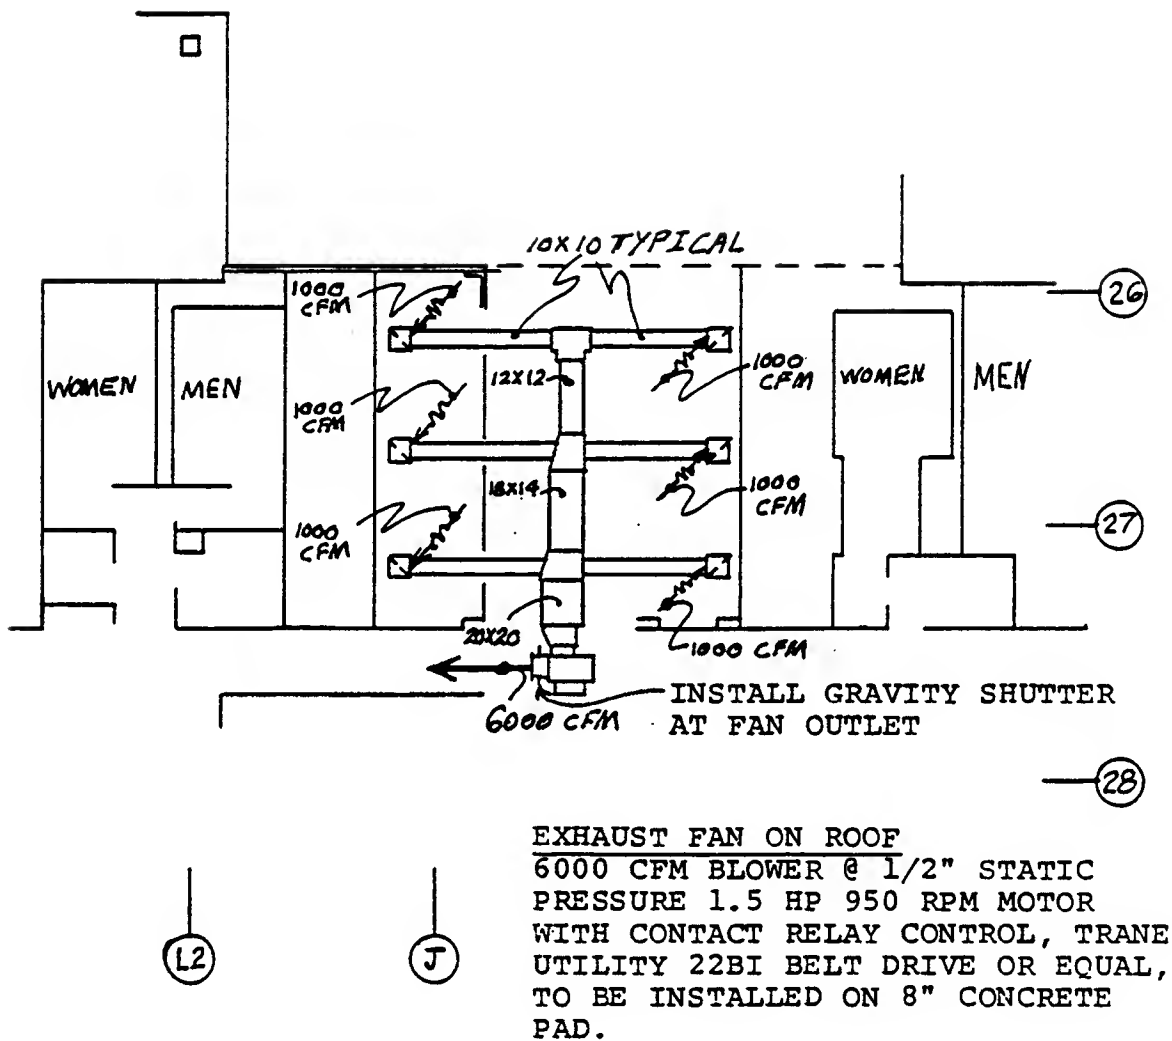
FIGURE D-17. ABOVE GRADE ELEVATOR EXHAUST SYSTEM

Prevention of Above Grade Vertical Migration - Thermally driven pollutant carrying air flowing into the corridors of the upper floors from the above grade shafts can only be prevented by eliminating the infiltration mechanism. Since this mechanism exists because of pressure differentials, the simplest and most certain preventive measure is to maintain the above grade vertical components of the migration paths at pressures lower than possible on the 8th floor. In determining this pressure, worst case conditions should be assumed, such as, the coldest expected atmospheric temperature.

Recommended Designs of Fan Modifications - Designs for the above recommended fan modifications to the above and below grade stairwells and elevator shafts are presented in Appendix D. Cost estimates to accomplish these modifications, and the balancing and adjusting of the HVAC system are also presented in Appendix D.

A reduced set of drawings representing the USIA building are presented in Figures D-1 through D-16. The drawings and specifications for the design of the modifications necessary to provide the recommended pressure conditions in the building's above grade stairwells and elevator hoistways are presented in Figures D-17 and D-18. The designs for the modifications to the above grade stairwells and elevator hoistways are planned as rooftop installations.
